Technical Series

00-138

PERFORMANCE OF A BRICK VENEER/STEEL STUD WALL SYSTEM

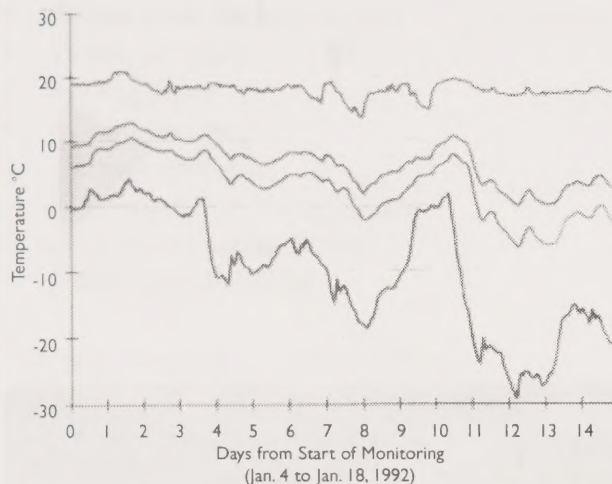
Figure 1: Temperature profile at stud

Thermocouples on stud flanges recorded different temperatures than those located on the corresponding gypsum board surfaces midway between studs. **Figure 1** shows the thermal profile through the wall at a stud, while **Figure 2** shows the profile midway between studs, for the same time period.

In -20° C weather the interior surface was as much as 3.5° C colder at the stud locations than midway between studs. Severe dust patterns indicating stud locations (and even drywall screws) were observed after the first year, as can be seen in **Photograph 5**.

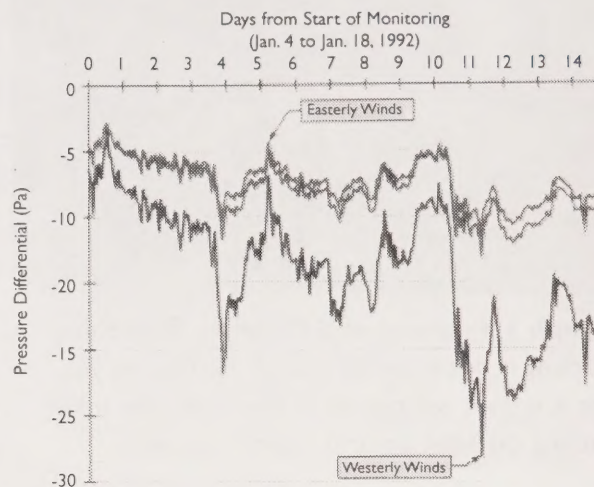
Figure 3: Hourly average pressure differences (before modification of venting)

Pressure taps were located at the exterior, in the cavity, in the stud space, and on the interior. **Figure 3**, typical for winter conditions, shows that the pressure on the interior was usually higher than on the exterior. The pressure difference driving air outward was reduced, but not reversed, by wind toward the wall, and wind away from the wall increased it. The graph also shows that the cavity behind the brick is pressure-moderated, not pressure-equalized. In fact, at least in winter, the cavity at this location was usually at a higher hourly average pressure than if it had been compartmented and pressure-equalized to the exterior. Two significant pressure drops occur, the first from the interior to the stud space, the second across the brick veneer. The relative magnitude varies, but at times the pressure difference across the brick is larger than that across the rest of the wall. Dust left in the insulation, shown in **Photograph 4**, is a further indication of air leakage.

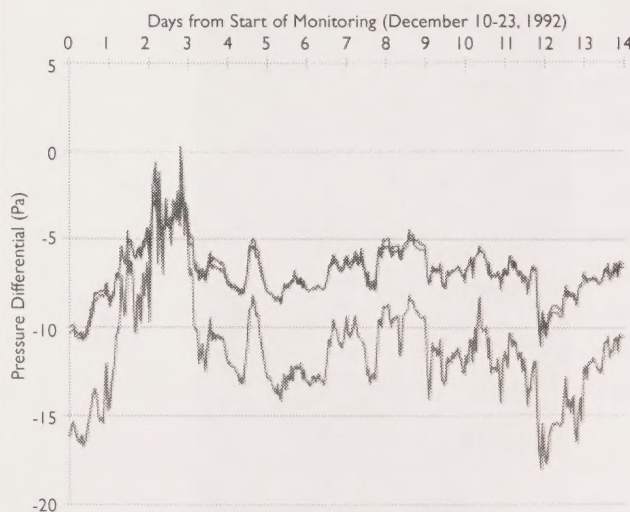
Figure 4: Hourly average pressure differences (after adding cavity vents)

Figure 4 shows that the resistance of the brick veneer remained significant after the addition of vents. The contribution to air flow resistance of the brick was reduced from about a half of the total pressure drop to about a third, while the pressure across the air barrier increased to about two thirds. (Note that 0 Pa is not at

the top of the graph, as it is in Figure 3). Because flow increases exponentially with pressure difference, with the same equivalent leakage area of the interior air barrier, adding the vents presumably caused an increase in air leakage.

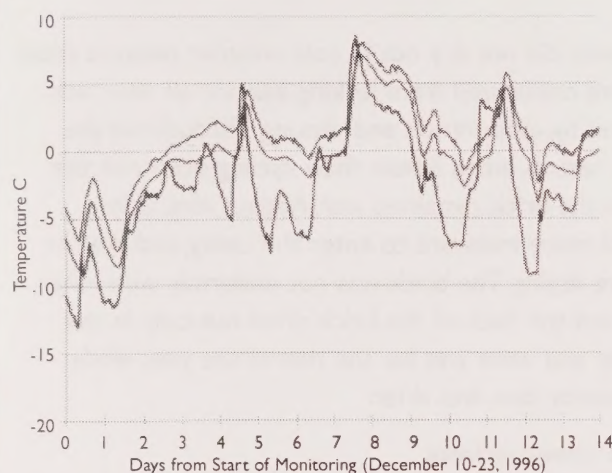
Figure 5: Temperatures of interior brick face, cavity dewpoint, and exterior air

As a result of air leakage primarily, condensation occurred on the inner surface of the brick veneer almost all of the time during late fall and winter. **Figure 5** shows the surface temperature at the back of the veneer, in relation to the dewpoint temperature of the air in the cavity and the exterior air temperature. During the period shown, the brick surface temperature was constantly below the dewpoint temperature, indicating that condensation was occurring. Even when exterior air

temperature rose above the cavity dewpoint (when a period of drying might be expected), although the cavity dewpoint temperature rose, the brick remained colder.

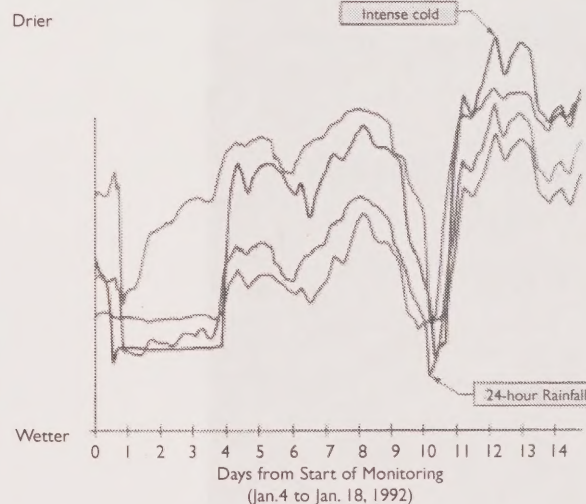
Figure 6: Relative wetness of brickwork

Moisture sensors revealed that in fall, winter, and spring the interior face of the brick was relatively wet, much more so than the exterior. When it rained, the exterior surface rapidly became wet, but dried soon after. Until the vents were added at the top of the cavity, rain penetration performance was satisfactory (after they were added the vents allowed more rain to enter the cavity). Although the wall seemed well constructed and relatively airtight, moisture problems were mainly caused by air leakage. **Figure 6** shows, in relative terms, the amounts of moisture in the brickwork, at inside and exterior faces, for locations near the roof slab, and at

the floor level. In order to interpret this graph, remember that when moisture freezes, the sensor reports a false dry condition. This possibility can be judged by reading the exterior temperature, or the sheathing temperature, depending on which surface of the brick is of interest, from **Figure 2**.
